CRASH INJURY EVALUATION

DYNAMIC TEST OF A COMMERCIAL-TYPE PASSENGER SEAT INSTALLATION IN AN H-21 HELICOPTER

TRECOM Technical Report 63-24

DYNAMIC TEST OF A COMMERCIAL-TYPE PASSENGER
SEAT INSTALLATION IN AN H-21 HELICOPTER

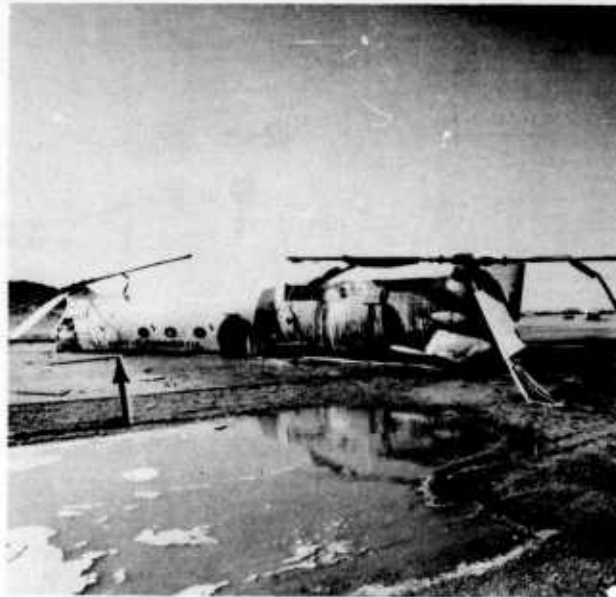
Figure 7. View of H-21 Test Vehicle, Postcrash. The general location of the commercial passenger seat is shown by arrow.

The entire lower structure of the forward fuselage section, including fuselage skin, floor support structure, and lower section of body frames, was crushed by impact of the helicopter on the runway. The left side of this lower structure was crushed more severely than the right side, due to impact with approximately 4 degrees left roll. Interior views showing the extent of buckling of the floor panels throughout the cabin area are given in Figures 8 and 9.

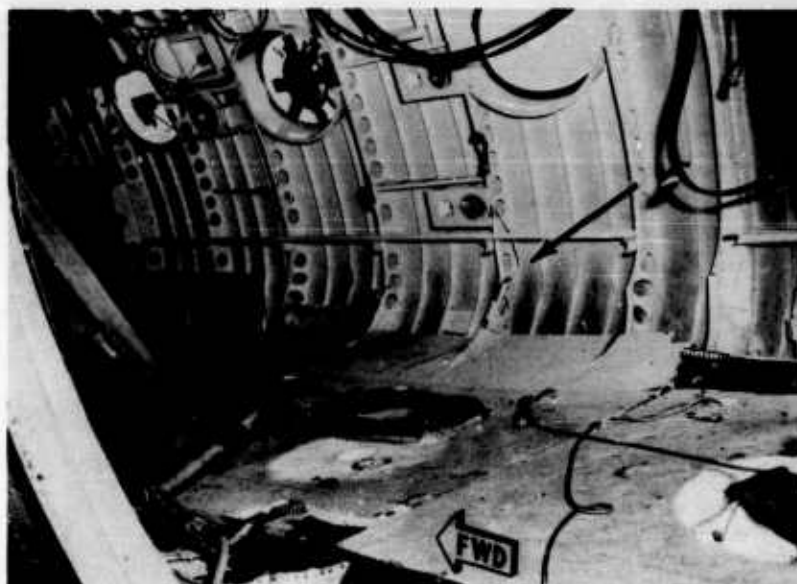
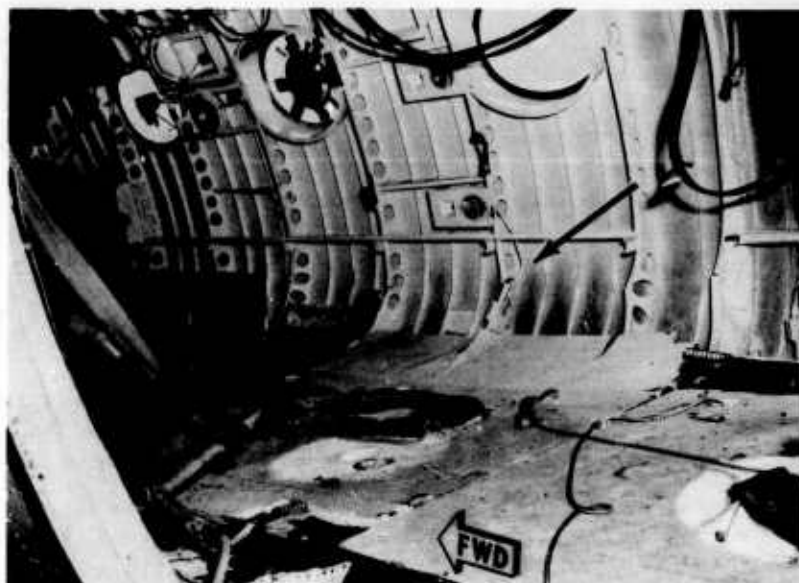
Generally, the fuselage structure above the normal troop seat attachment points, approximately 17 inches above the floor line, remained intact on both sides of the aircraft, while structure below this line was crushed extensively.

Figure 8. Passenger Compartment, Rear.
Arrow shows the buckling of fuselage frames.

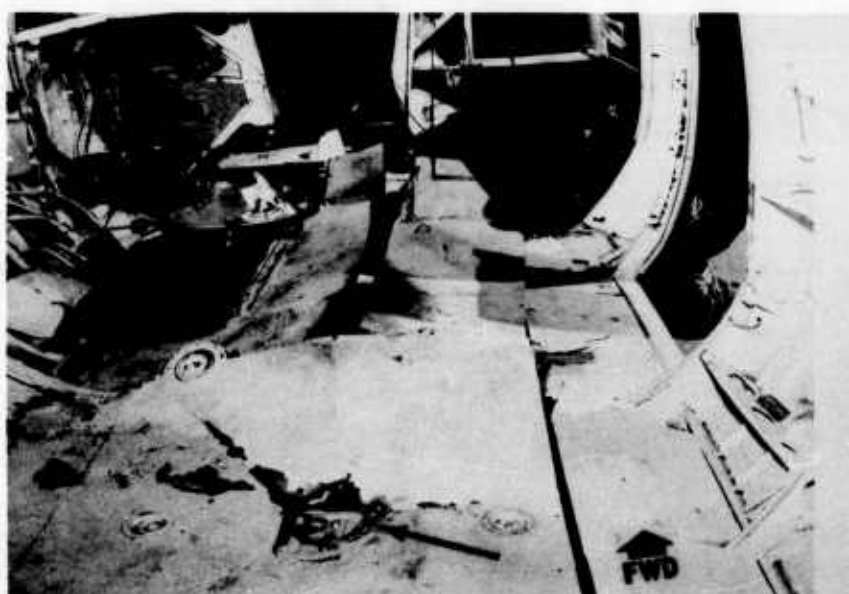
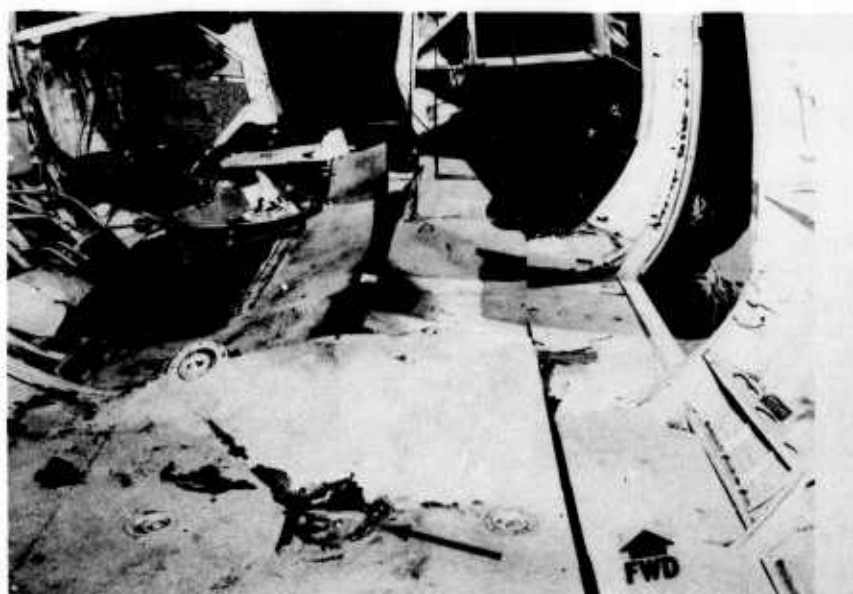
Figure 9. Passenger Compartment, Front, With Commercial
Passenger Seat Removed.
Arrow shows floor attachment plate for seat.

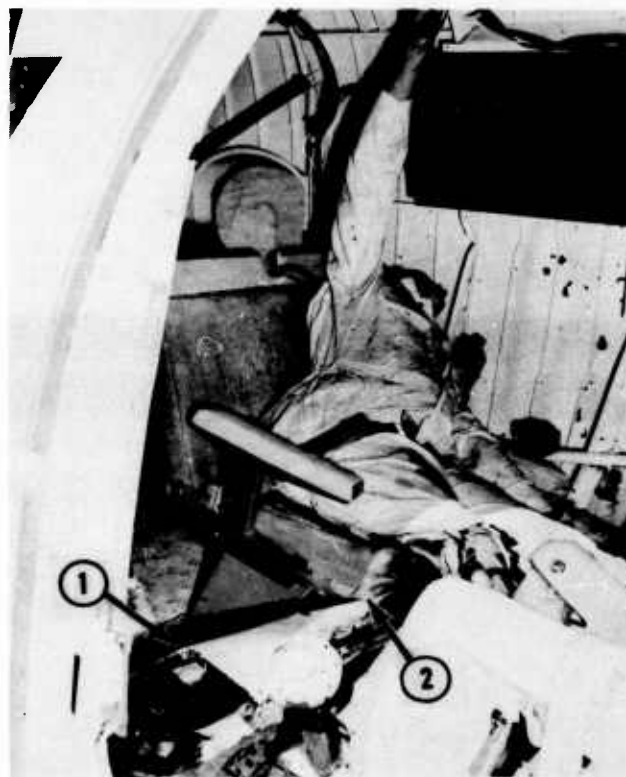
Figures 10 and 11 show postcrash views of the seat and dummy. The seat was basically intact; however, there was considerable deformation in most elements of the seat, as shown in Figure 11. Partial separation of several parts of the seat occurred, although no complete failures of any component of the seat were observed.

Figure 10. Postcrash View of Commercial Passenger Seat and Dummy.

Arrow 1 shows floor and supporting structure upset in front of seat by nose wheel and nose gear. Arrow 2 shows contact of seat with buckled floor structure.

It is possible, and even probable, that the contact of seat and floor structure as seen in Figures 10 and 11 may have provided some longitudinal support to the seat, yet the performance of the seat must be considered as excellent in view of the existing specifications to which the seat is designed.

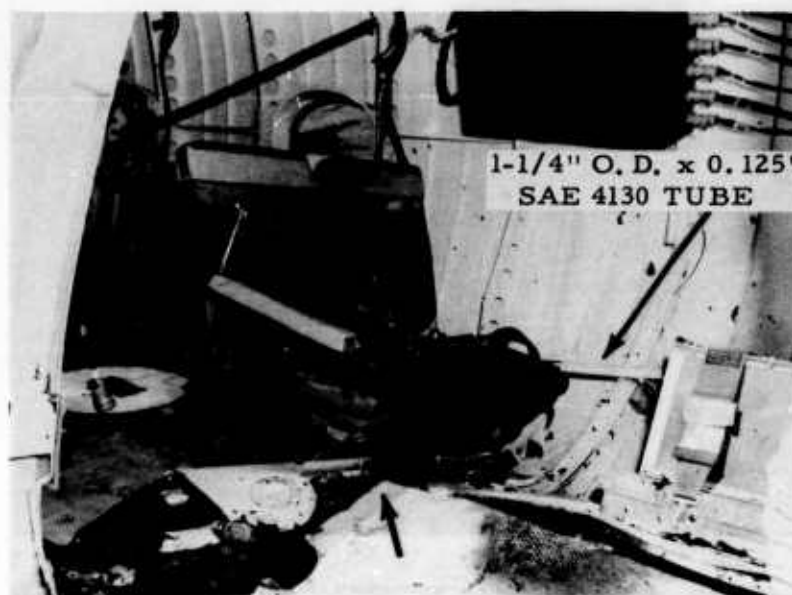
Figure 11. Postcrash View of Commercial Passenger Seat,
With Dummy and Sandbags Removed.
Arrow shows contact of forward edge of seat with buckled
floor structure.

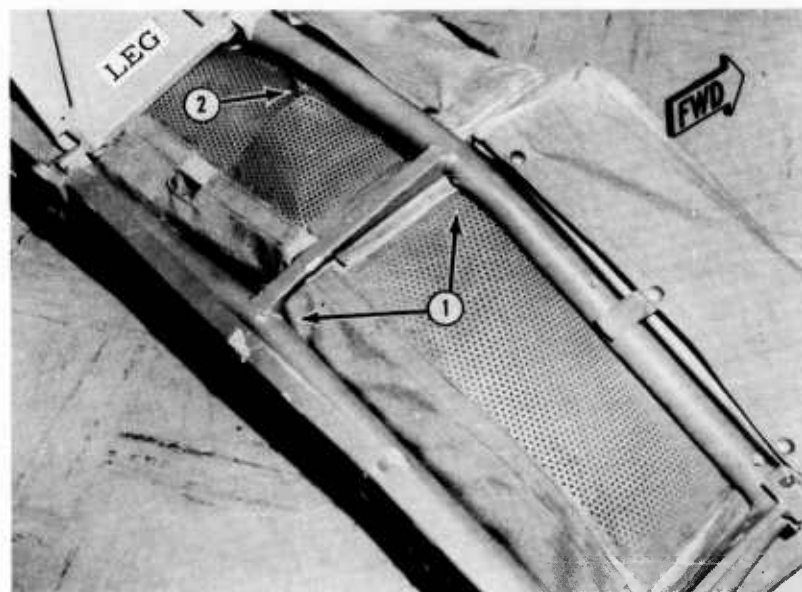
Figure 12 shows a postcrash view of the bottom of the seat, illustrating the deformation in the main structure. There was a fracture of the rear tube at the wall end.

Both the front and the rear tubes were bent at the center (arrow 1). In addition, the front tube was further bent near the leg of the seat. This bend occurred directly beneath the dummy. Note that the seat pan is fractured in the same area (arrow 2). The front tube has a larger permanent vertical deflection than the rear tube, as would be expected in accidents having forward and downward velocity components at primary impact; i. e., the forward tube can be expected to carry a major portion of the vertical inertia load.

Figure 12. Bottom Structure of Seat, Postcrash.

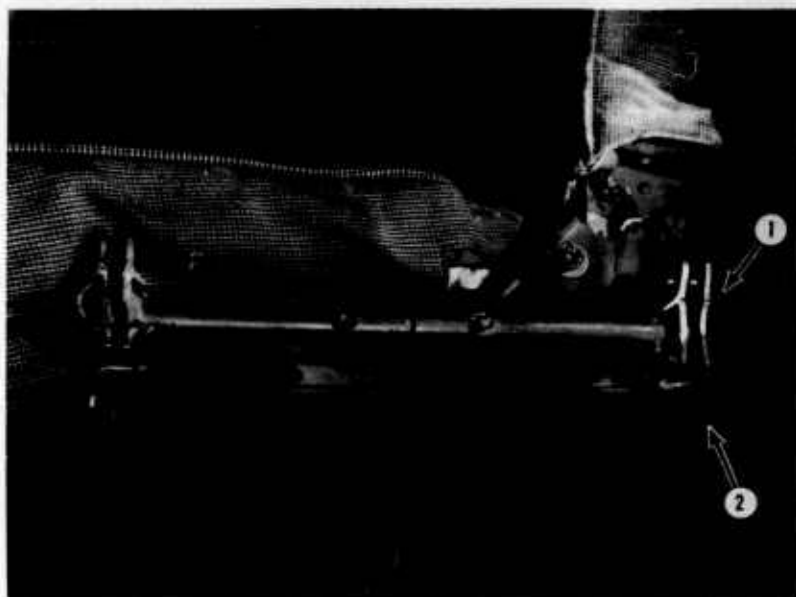
Figure 13 shows the condition of the wall attachment portion of the seat. Arrow 1 shows the fracture of the rear tube. The bent flange (arrow 2) was a support for a locking bar used in folding the seat. This bar was removed prior to the test to allow modification of the test seat (an early model) to conform strengthwise to the proposed

service model. The 4130 tube to which the seat was attached at the wall of the aircraft remained in place, with slight (5 degrees or less) bends in the vertical and horizontal planes containing the axis of the bar.

Figure 13. Wall Attachment, End of Seat, Postcrash.

It should be recalled that the wall support of this seat was quite rugged (1/8-inch wall x 1.25-inch O. D. SAE 4130 tube), yet it was permanently deformed with approximately 5 degrees of bend in each of two planes. Failure of the normal H-21 aluminum support would have undoubtedly occurred as has been shown by previous experience with troop seats.*

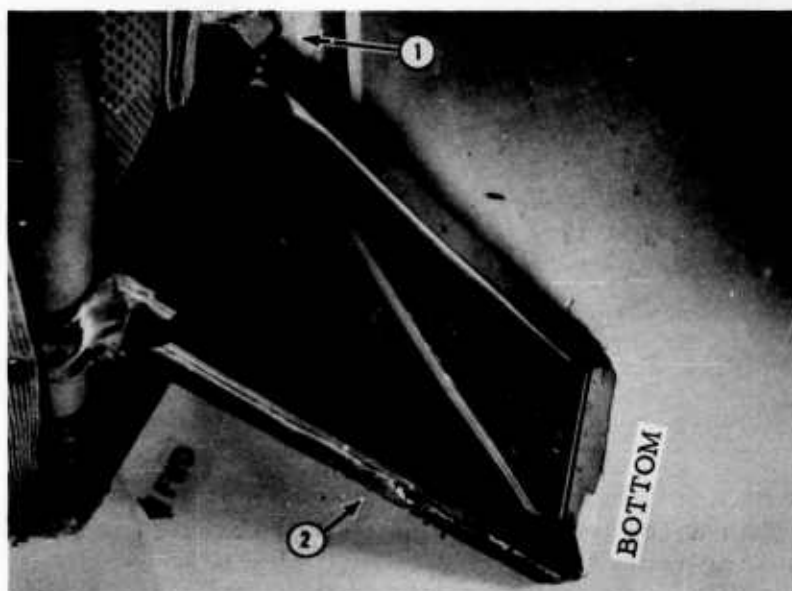
Figure 14 shows the folding leg of the commercial passenger seat. Arrow 1 shows the deformation and fracture of the aft leg fitting beneath the seat. Arrow 2 indicates the area of contact of the forward edge of the leg with the buckled floor panel. (See also Figures 9, 10, and 11.)

Figure 14. Folding Leg of Commercial Passenger Seat.
 Arrow 1 shows a partial failure of the fitting. Arrow
 2 shows region of contact of leg with buckled floor.

1. The folding leg of the commercial passenger seat be redesigned to incorporate energy absorption capability to reduce peak vertical accelerations.
2. The attachment of the seat to the wall of service aircraft be capable of developing the full potential of the seat. The standard troop seat attachments in the H-21 are inadequate from this standpoint.
3. Additional restraints in the form of shoulder harnesses be installed.
4. Provision be made for reducing injury through contact of the lower extremities with the rear main beam of the seat in all installations involving tandem seating.

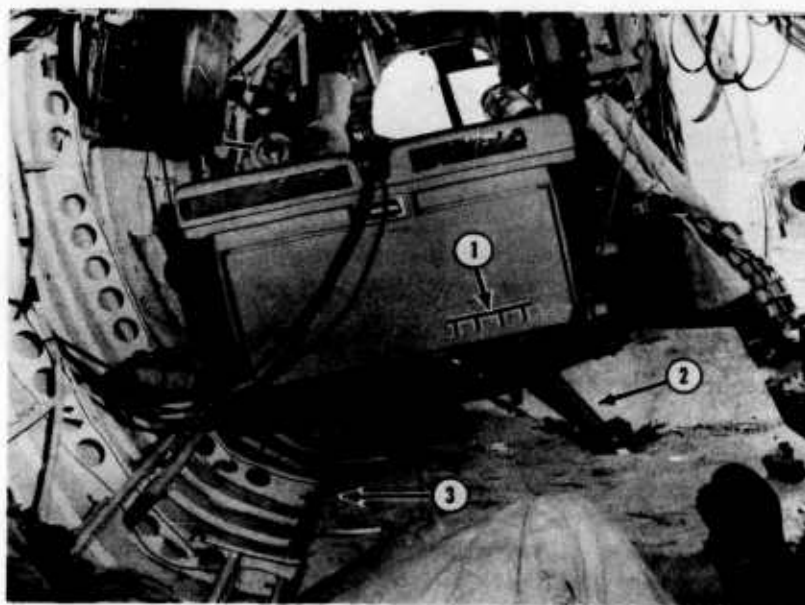
Figure 15 gives an overall rear view of the orientation and condition of the seat immediately after the crash. Arrow 1 shows the region of application of vertical inertia load due to the passenger in the aisle position. The position of the seat leg provides an almost direct load path to the floor. Thus, had the 200-pound dummy and the 120-pound sandbags been reversed in position, it is probable that a more extensive deformation of the forward main tubular structure would have resulted. Initially, the leg of this seat was vertical, as shown in Figures 2 and 3. The apparent rightward shifting of the floor attachment for the leg at arrow 2 in Figure 15 was actually due to the displacement of the left wall of the aircraft to the left with respect to the centerline of the floor. This movement was due to extensive buckling of the fuselage frames along the entire left side of the cabin, as shown at arrow 3.

Figure 15. Rear View of Seat, Postcrash.

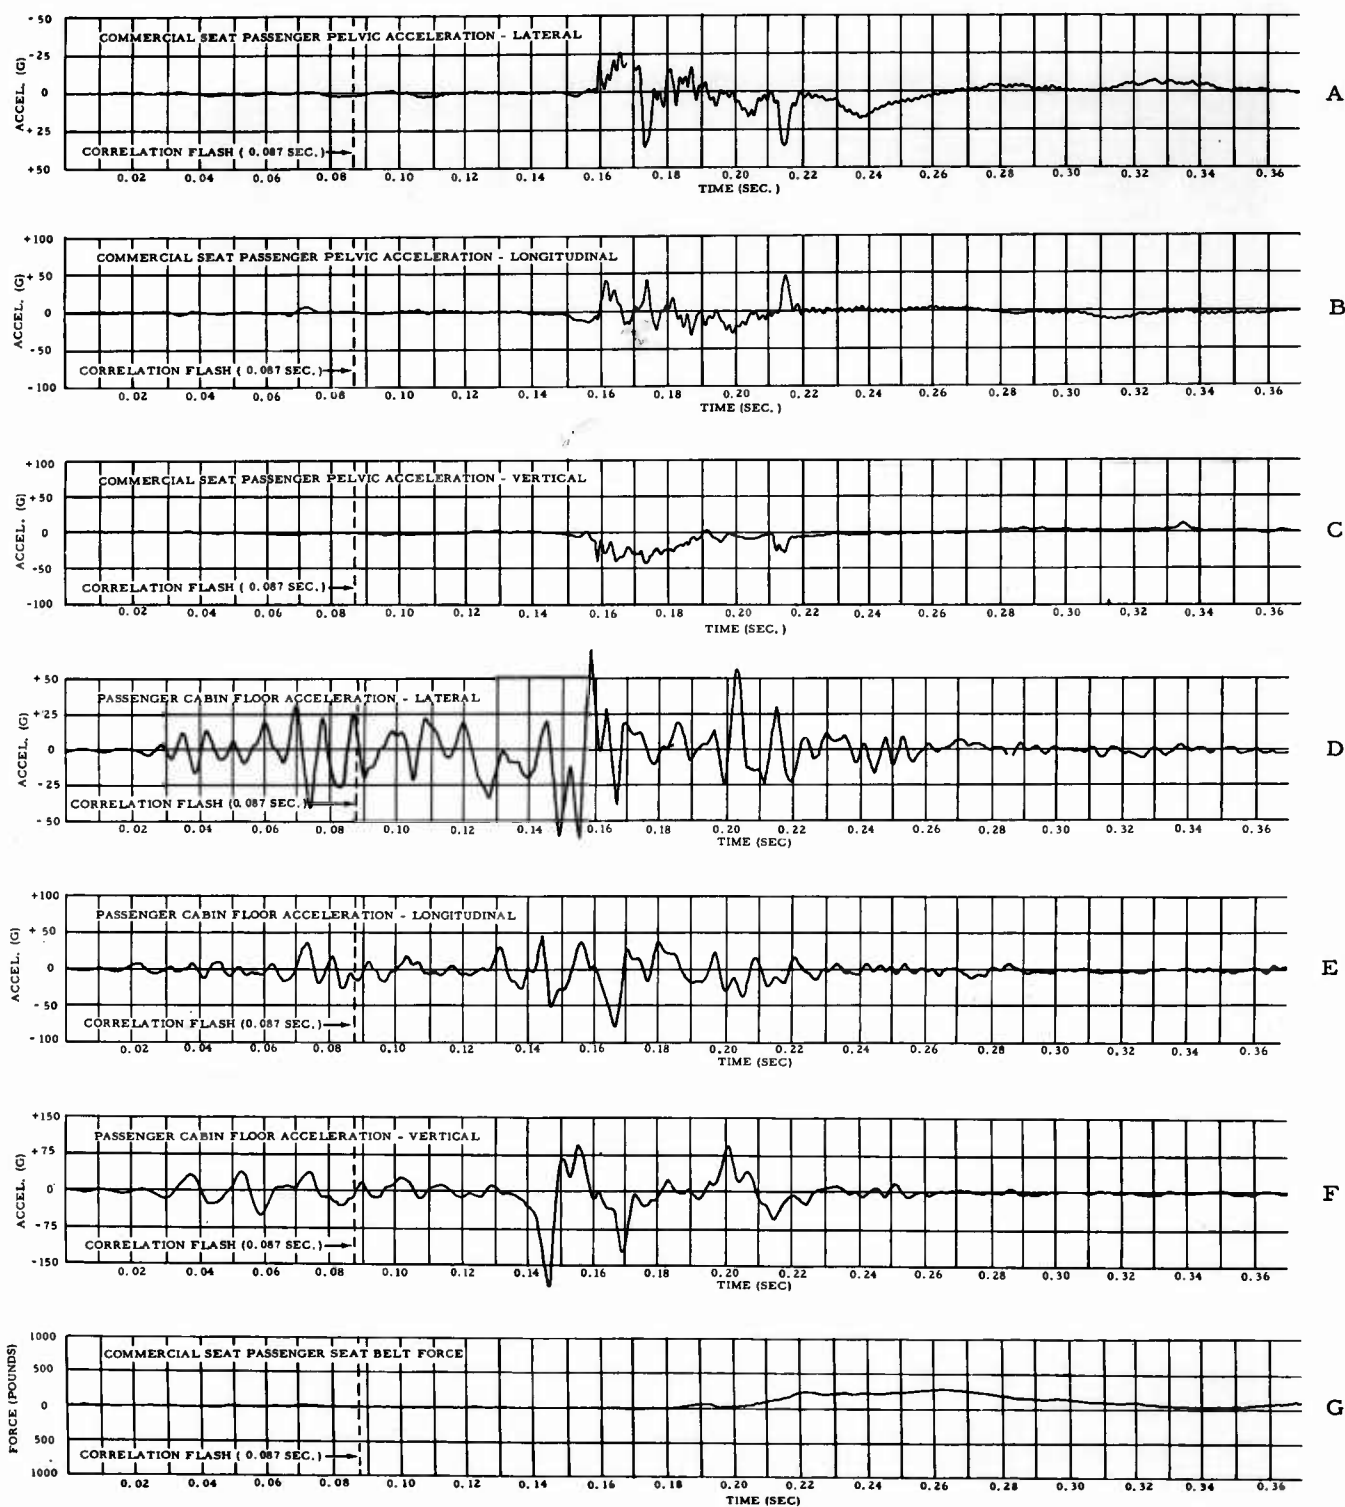
The accelerometer traces applicable to analysis of the commercial passenger seat described in this report are presented in Figure 16, including (a) the records of lateral, longitudinal, and vertical acceleration in both the pelvic region of the dummy and at the passenger cabin floor level and (b) the passenger seat belt force. In these records, time zero corresponds to first contact of the aircraft as noted on Figure 16C. The primary seat deformation and the buckling of the floor reached maximums at about 0.215 second.

Figures 16A, B, and C show the acceleration environment in the crash as recorded by three accelerometers mounted in the dummy pelvic region. It should be noted that the acceleration in a given direction (vertical, lateral, or longitudinal) refers to the direction measured with respect to the dummy pelvis, not to the airframe on the ground. Considerable movement of the dummy (including flailing of arms and legs) occurred with respect to the airframe, and thus the "vertical" alignment of the vertical accelerometer at impact was not maintained during the progress of even the primary pulse. Figure 17 has been presented for the convenience of the reader in visualizing this motion of the dummy. Such displacements gave rise to interactions between the lateral, vertical, and longitudinal inputs as picked up by the respective accelerometers.

Reference to Figure 16C shows that the primary "vertical" acceleration in the dummy occurred in the interval from 0.14 second to 0.22 second immediately following the impact of the fuselage proper with the runway.

Observation of high-speed films from on-board cameras shows, as noted in Figure 16C, that during this interval the floor in the vicinity of the seat underwent the deformation shown in Figures 10 and 11, and that the dummy seat and dummy itself (Figure 17) underwent maximum displacement. Two separate pulses are evident in Figure 16C, i. e., a half sine wave in the interval from 0.15 to 0.19 second, followed by a smaller pulse at 0.21 second. An average of about 33G was maintained for some 0.025 second, accounting for a change in velocity of about 26 feet per second. The recorded "vertical" pulse would have probably been somewhat greater had the dummy remained truly vertical throughout the impact. The recorded "lateral" and "longitudinal" accelerations were more of an oscillatory nature, as seen in Figures 16A and B.

The acceleration pulse occurring at 0.215 second and recorded on all three accelerometers was probably associated with the contact of the seat with the buckled floor structure as shown in Figures 10, 11, and 14. Although no definite proof of this fact exists at this time, it is reasonably certain as observed in the high-speed films. Sign conventions are in accordance with those recommended by C. F. Gell, M. D., D. Sc., in December 1961, Issue of Aerospace Medicine, Vol. 32, No. 12, i. e., Eyeballs Right (lateral), Eyeballs In (horizontal), and Eyeballs Down (vertical).

Figure 16. Accelerometer-Time and Force-Time Histories.
